## NMR PIPETECTOR Scientific Report (No.13)

# Anti-Corrosion Application, Supermarket and Apartment Maintenance Center (Wakabadai Housing Management Center)

## To stop corrosion in hot and cold water pipes of air conditioner and prolong life of pipe

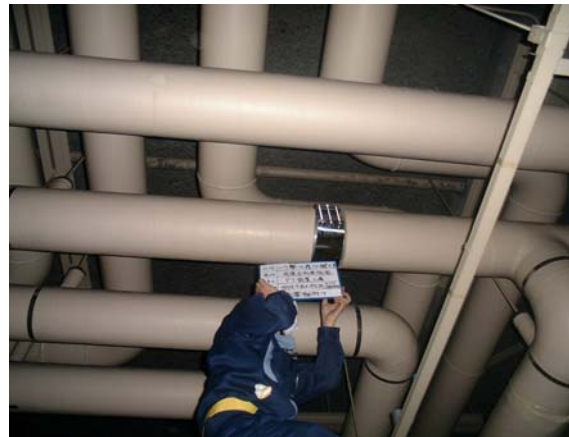
On outlet of the hot and cold water  
pipes

Address	Yokohama, Kanagawa Prefecture, Japan
Building Summary	19 years after being built
Installation Day	April 10, 2001
Installation Place Number of Installed NMR PIPETECTOR	On outlet hot and cold water pipes of the generator (SGP 200mm) NMR PIPETECTOR PT- 200DS × 3 units  On outlet water pipe (SGP 65mm) NMR PIPETECTOR PT- 75DS × 1 unit

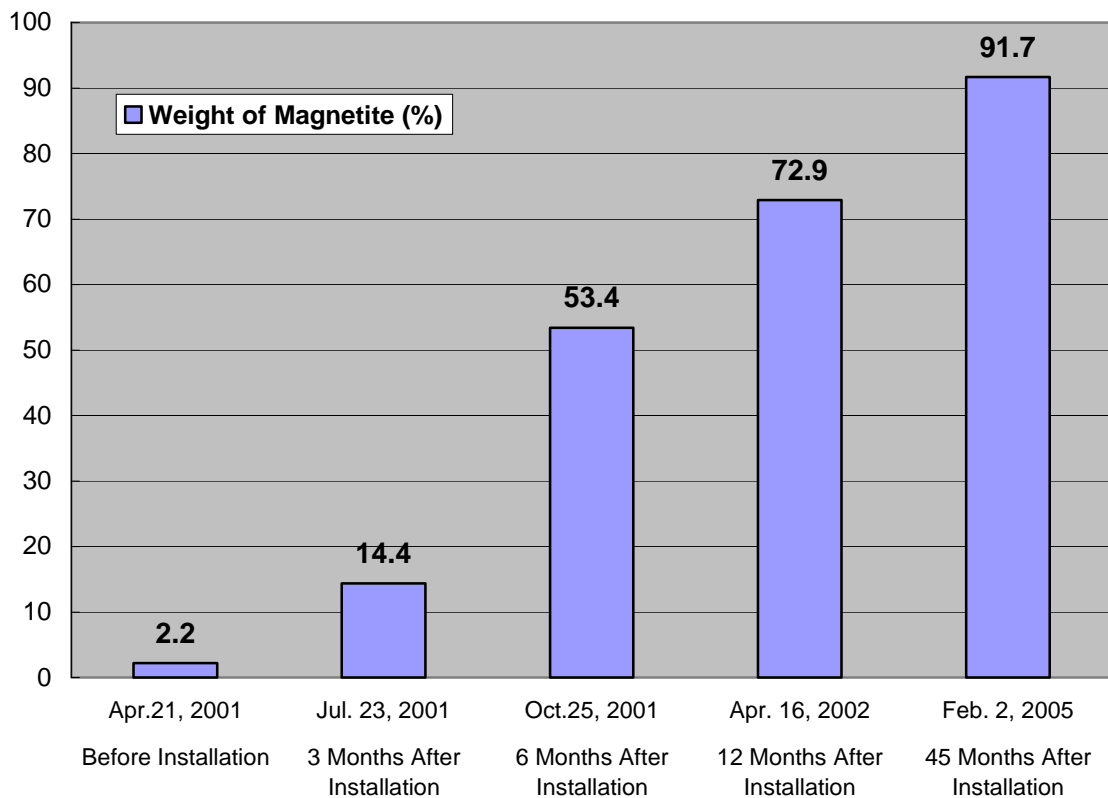
Details of Test	Before Installation Apr. 21, 2001	3 months after Installation Jul. 23, 2001	6 months after Installation Oct. 25, 2001	12 months after Installation Apr. 16, 2002	45 months after the Installation Feb. 2, 2005
Weight (%) of magnetite (Fe <sub>3</sub> O <sub>4</sub> )	2.2%	14.4%	53.4%	72.9%	91.7%

**Change of Weight (%) of Magnetite(Fe<sub>3</sub>O<sub>4</sub>)**

It has been 22 years since this building was built, they were worried about much development of corrosion inside of the water pipes and need of replacing with new pipes because of frequent water leaks. However, since the pipes supply hot and cold water to 4 apartment buildings including commercial facilities such as a big supermarket, it was impossible for them to accept the works of replacing with new pipes, which is necessary to stop supplying water. NMR PIPETECTOR was installed for the measurement of these problems. After the installation of NMR PIPETECTOR, water pipes do not leak anymore and the ratio of mass analysis of magnetite shows that the renewal of water pipes was proved by reducing corrosion to magnetite. **The ratio of mass analysis of magnetite increased from 2.2% (which means that corrosion is 97.8%) before the installation of NMR PIPETECTOR up to 72.9% 12 months after the installation, and increased to 91.7% (which means that corrosion is 8.3%) 45 months after the installation.** It is proved that the replacement with new pipes will not be necessary forever if the ratio of magnetite increases up to 100% in the future and if the outside of the pipes will not rust.
