NMR PIPETECTOR Scientific Report, in Japan

Anti-Corrosion Application, Head Office of Japanese Red Cross Society

NMR Corporation

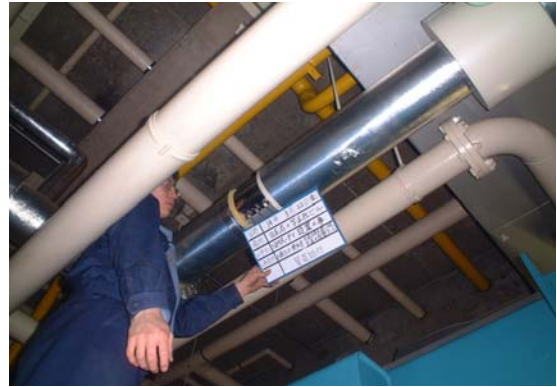
Outlet pipe from heating and cooling generator (PT-125DSx1)

The Head Office of Japanese Red Cross Society (JRCS) is 25 years old and the corrosion in the heating and cooling pipe had been their concern. For the protection of the heating and cooling pipe from corrosion, one unit of NMR Pipetector was installed on the outlet pipe (galvanized pipe) from the heating and cooling generator. Before the installation, the weight percent of magnetite in the total rust was 36.6%, and NMR Pipetector unit was installed on March 22 of 2002. The weight percent of magnetite increased to 80% after 16 months of the installation, and 80.7% 36 months after the installation, so the weight percent of magnetite is 44.1% increase in 36 months. The corrosion formed inside of the pipe was mostly reduced to magnetite, and JRCS will not have to change the pipe in the future and will be able to use the existing pipework while the head office building exists.

Name of Building	Head Office of Japanese Red Cross Society : Minato-ku, Tokyo Japan
Building Summary	25 years old building
Installation Day	March 22, 2002
Installation Place Number of installed	Outlet main pipe from heating and cooling generator (SGP 125A) PT-125DSx1 unit

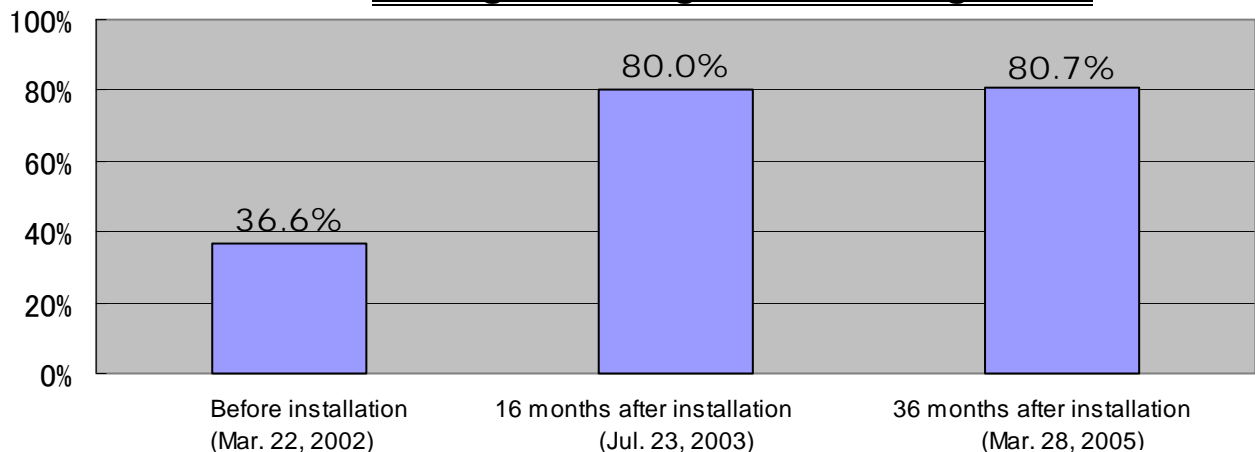
Change of Weight (%) of Magnetite

Before installation March 22, 2002	16 months after installation July 23, 2003	36 months after installation March 28, 2005	Increase from before installation
Magnetite weight percentage	36.6%	80.0%	80.7%	44.1%

■ Weight (%) of Magnetite
